# Educated roofing

Rio Roofing corrects leak issues on  
Roma High School in Texas

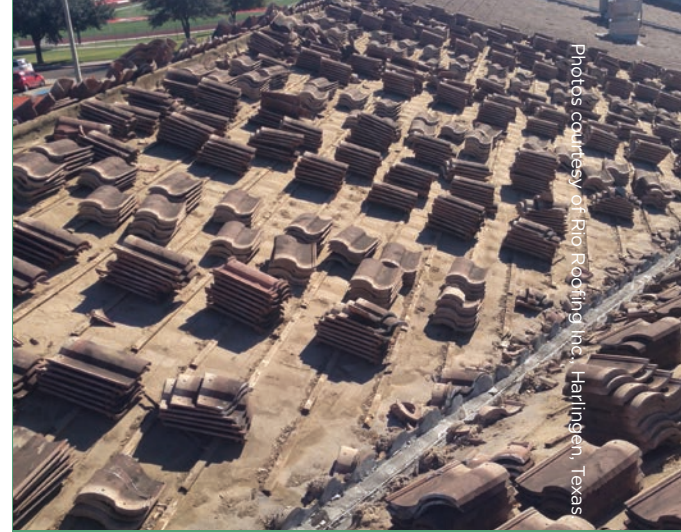
Rio Roofing workers removed the existing tiles from the 190,000-square-foot main roof areas.

Rio Roofing workers removed the existing tiles from the 190,000-square-foot steep-slope main roof areas. Because of the project’s location, it was not cost-effective to haul the tiles back to the shop.

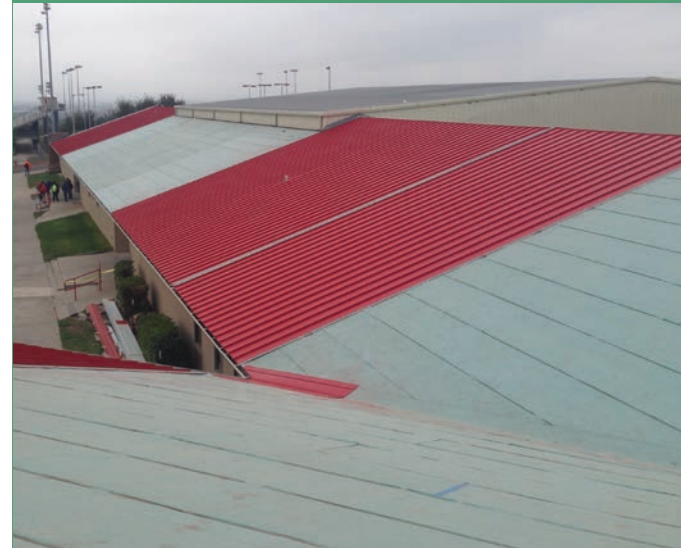
All the metal panels for the project were formed on-site by Rio Roofing craftsmen.

“We brought out the roll-former on weekends to run the panels because it draws a crowd,” Hichens says. “Obviously, with a school there are fewer people around on the weekends. Instead of having to deal with the cost and logistics of bringing in 190,000 square feet of 45-foot-long panels, we’re certified by McElroy Metal to manufacture the 138 and 238T panels with our own roll-former. All the panels on this project were site-formed. We also purchased a SnapTable Pro from Swenson Sheer to cut panels we installed in the valleys and to notch the panels.”

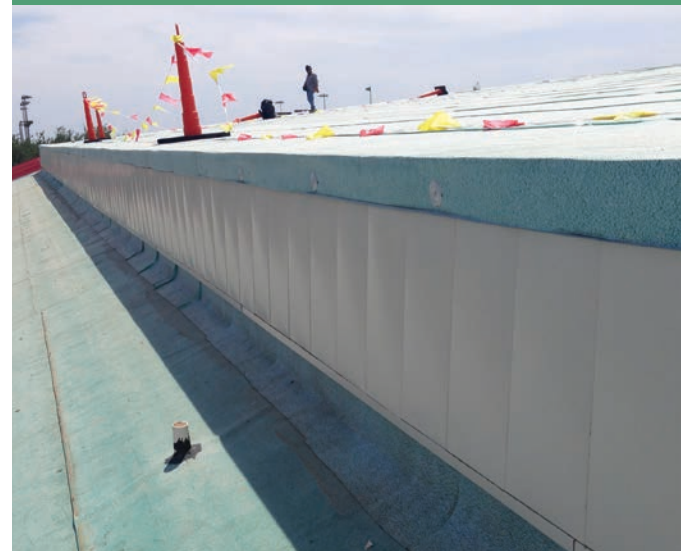
One area on the gymnasium with existing R-panels received an additional layer of 3/8-inch SECUROCK cover board between the EPS and Polystick MTS membrane.

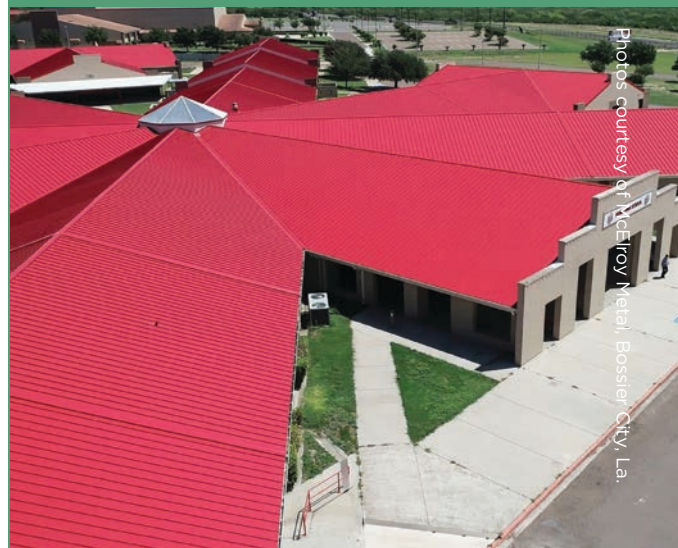
Rio Roofing workers fastened 141,800 lineal feet of McElroy Metal symmetrical standing-seam Galvalume® panels in PVDF Brite Red.

The Rio Roofing crew then mechanically fastened 3-inch-thick polyisocyanurate insulation to the existing layer of 5/8-inch-thick plywood on the metal deck. Next, workers laid self-adhering Polyglass Polystick® MTS followed by fastening 141,800 lineal feet of McElroy Metal 16-inch-wide, 24-gauge 138T symmetrical standing-seam Galvalume® panels in PVDF Brite Red.

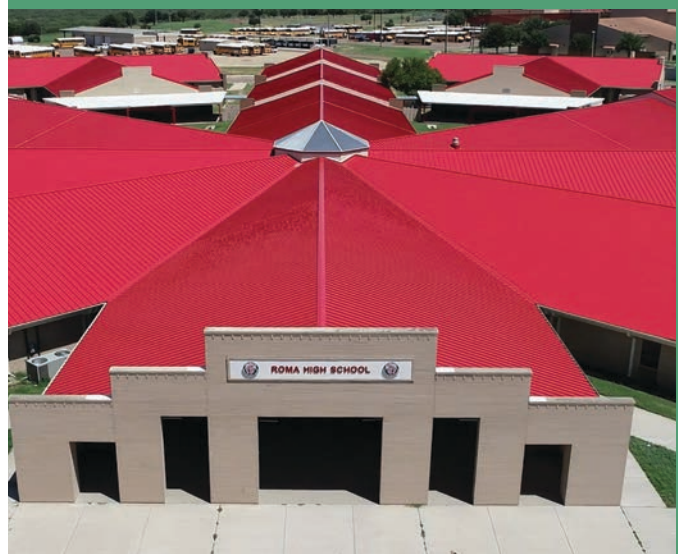
An aerial view of Roma High School's new metal roof system
