# Roofing

# Homework Pays Off

## Meticulous Preparation Sets Up Restoration Project for Success

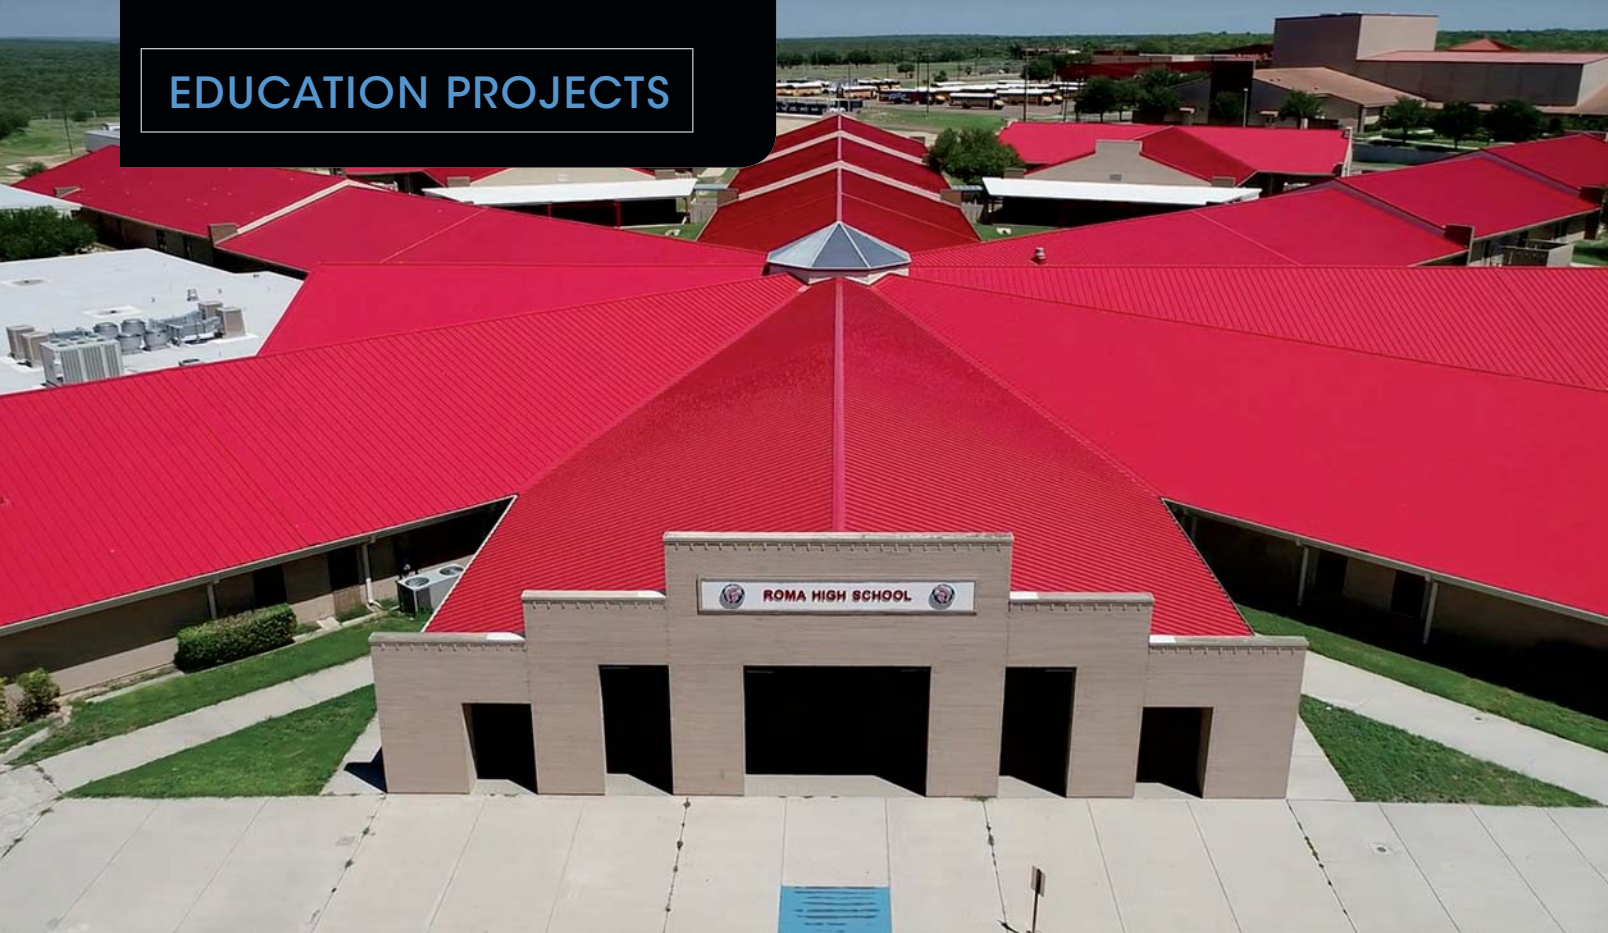
Roma High School in Roma, Texas, underwent a three-phase building envelope restoration plan in 2016-2017. After the walls were repaired and restored, the roof and mechanical equipment were replaced.

The restoration plan was split up into three phases. The first phase focused on restoring the walls and windows. The second phase encompassed roof replacement and installing new mechanical equipment. The third phase involved improving drainage, grading and other site repairs.

roof, the gymnasium, and two free-standing structures – the art and industrial arts buildings – that had been added over the years. The main tile roof was removed and replaced with McElroy’s 138T Panel, a 16-inch-wide, 24-gauge panel in Brite Red. McElroy’s 238T Panel, a 24-inch-wide, 24-gauge panel, was specified for the gym, as well as the art and industrial arts buildings. In a cost-saving measure, the color on the gym roof was changes to Galvalume Plus. In all, more than 233,000 square feet of metal roofing was installed.
